CORROSION INHIBITORS FOR LITHIUM CHLORIDE SOLUTIONS

U. S. Naval Civil Engineering Research and Evaluation Laboratory  
Port Hueneme, California

Project NY 030 019-1.04  
Technical Note N-328  
CORROSION INHIBITORS FOR LITHIUM CHLORIDE SOLUTION  
C. V. Brouillette

To present the results of studies and experimentations on the effects of various chemicals toward lessening the corrosive attack of 24 percent aqueous solutions of lithium chloride upon fire extinguishers and the materials from which they are fabricated.

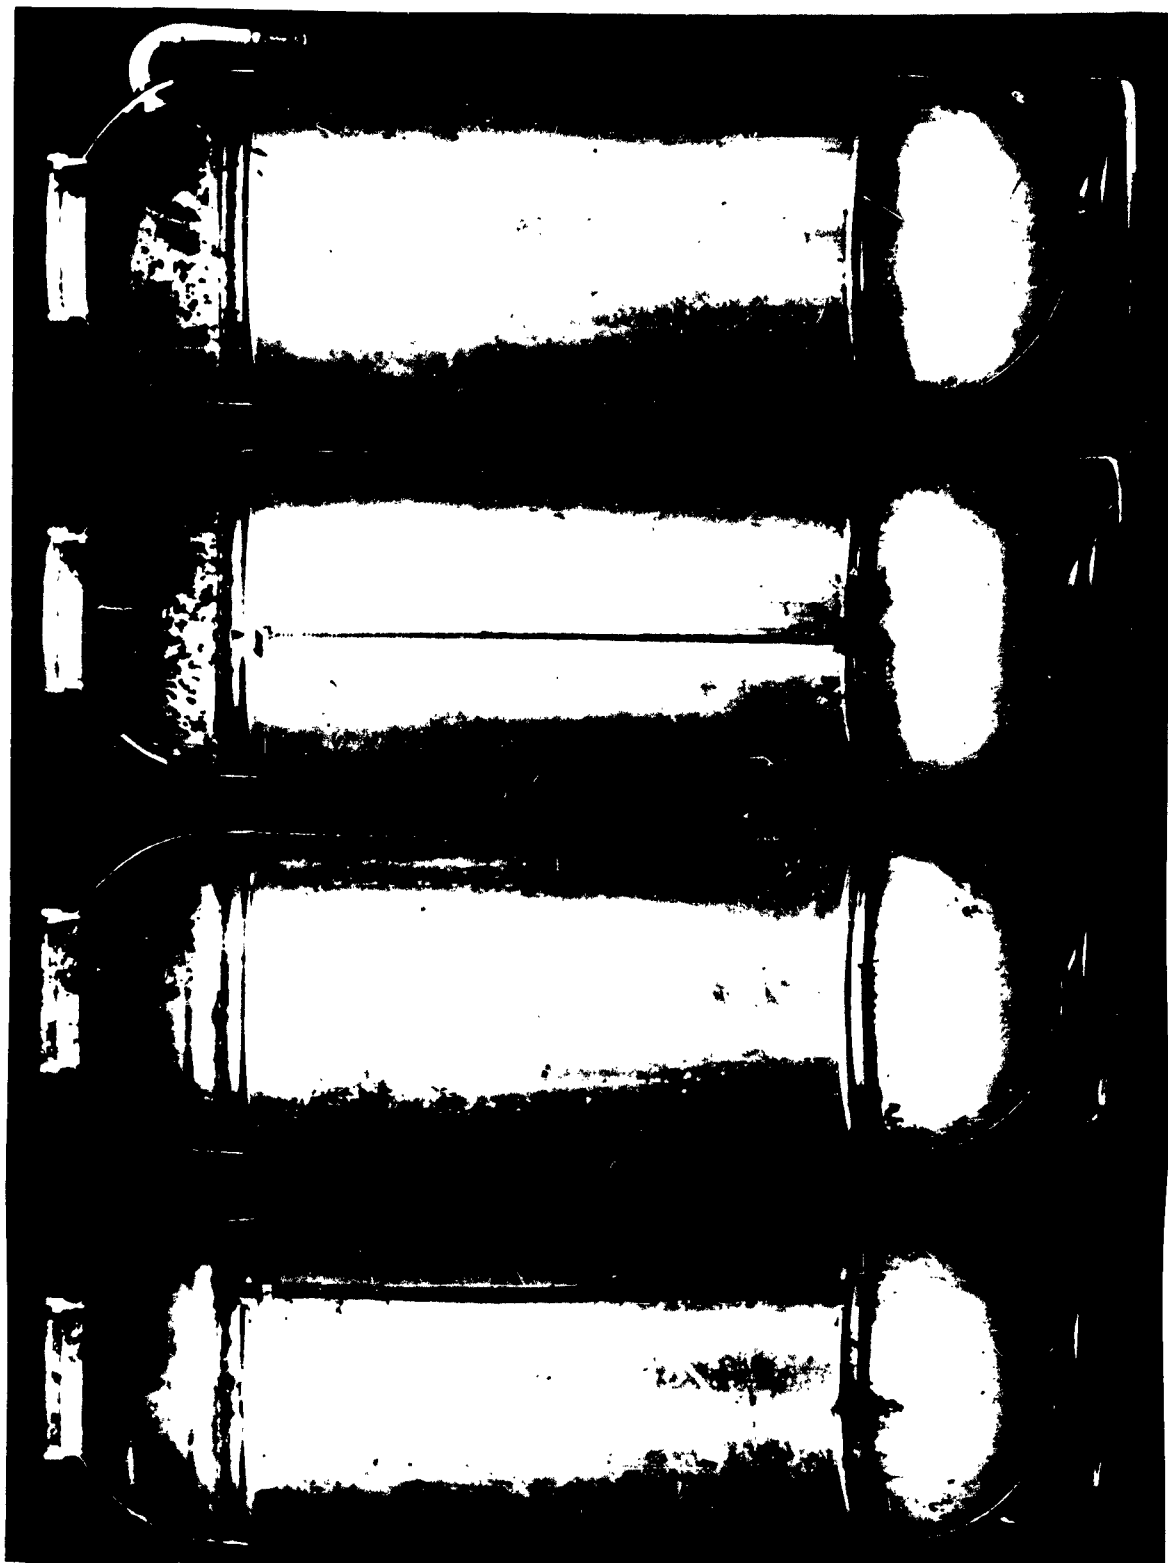
Figure 1. Stainless steel Extinguishers Nos. 1 and 2, Inside View.  
Austenitic Inconel holes formed by corrosion

All three stainless steel extinguishers were severely corroded around the welded seams at the top and bottom with only light corrosion occurring along the vertical seams, (figures 1 through 4). The attack along the vertical seam of extinguisher 1 containing the NRL sodium chromate inhibitor was greater than that along the vertical seams of Extinguishers 2 or 3 which contained sodium dichromate-oxalic acid or sodium dichromate as the inhibitors.

Stainless steel extinguisher 1, which contained the NRL sodium chromate inhibitor, rusted so rapidly in this area that three small holes appeared after 3 weeks accelerated exposure at 140°F (figures 1, 3, and 5). At the end of 4 weeks, extinguisher 2 containing sodium dichromate-oxalic acid inhibitor was corroded through at one place (figures 1, 4, and 6).

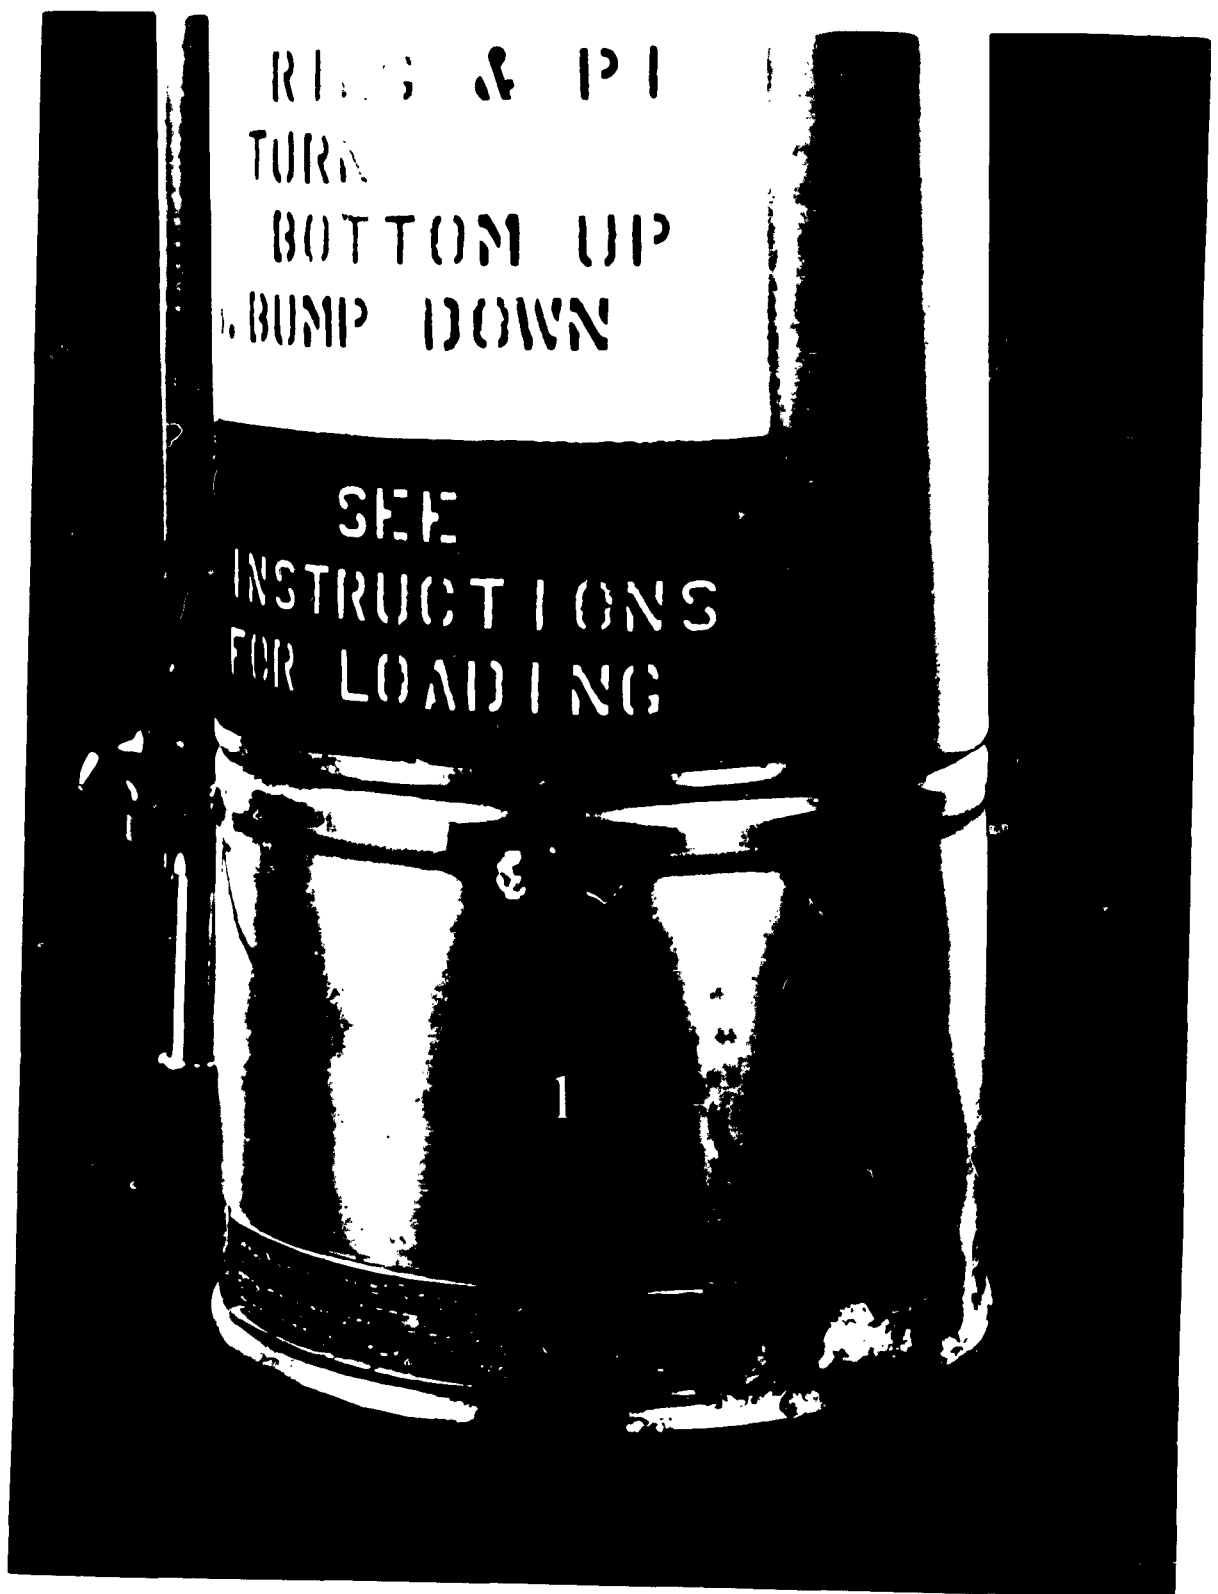
Figure 3. Stainless Steel Extinguisher No. 1, Outside View.  
Arrows locate holes formed by corrosion.

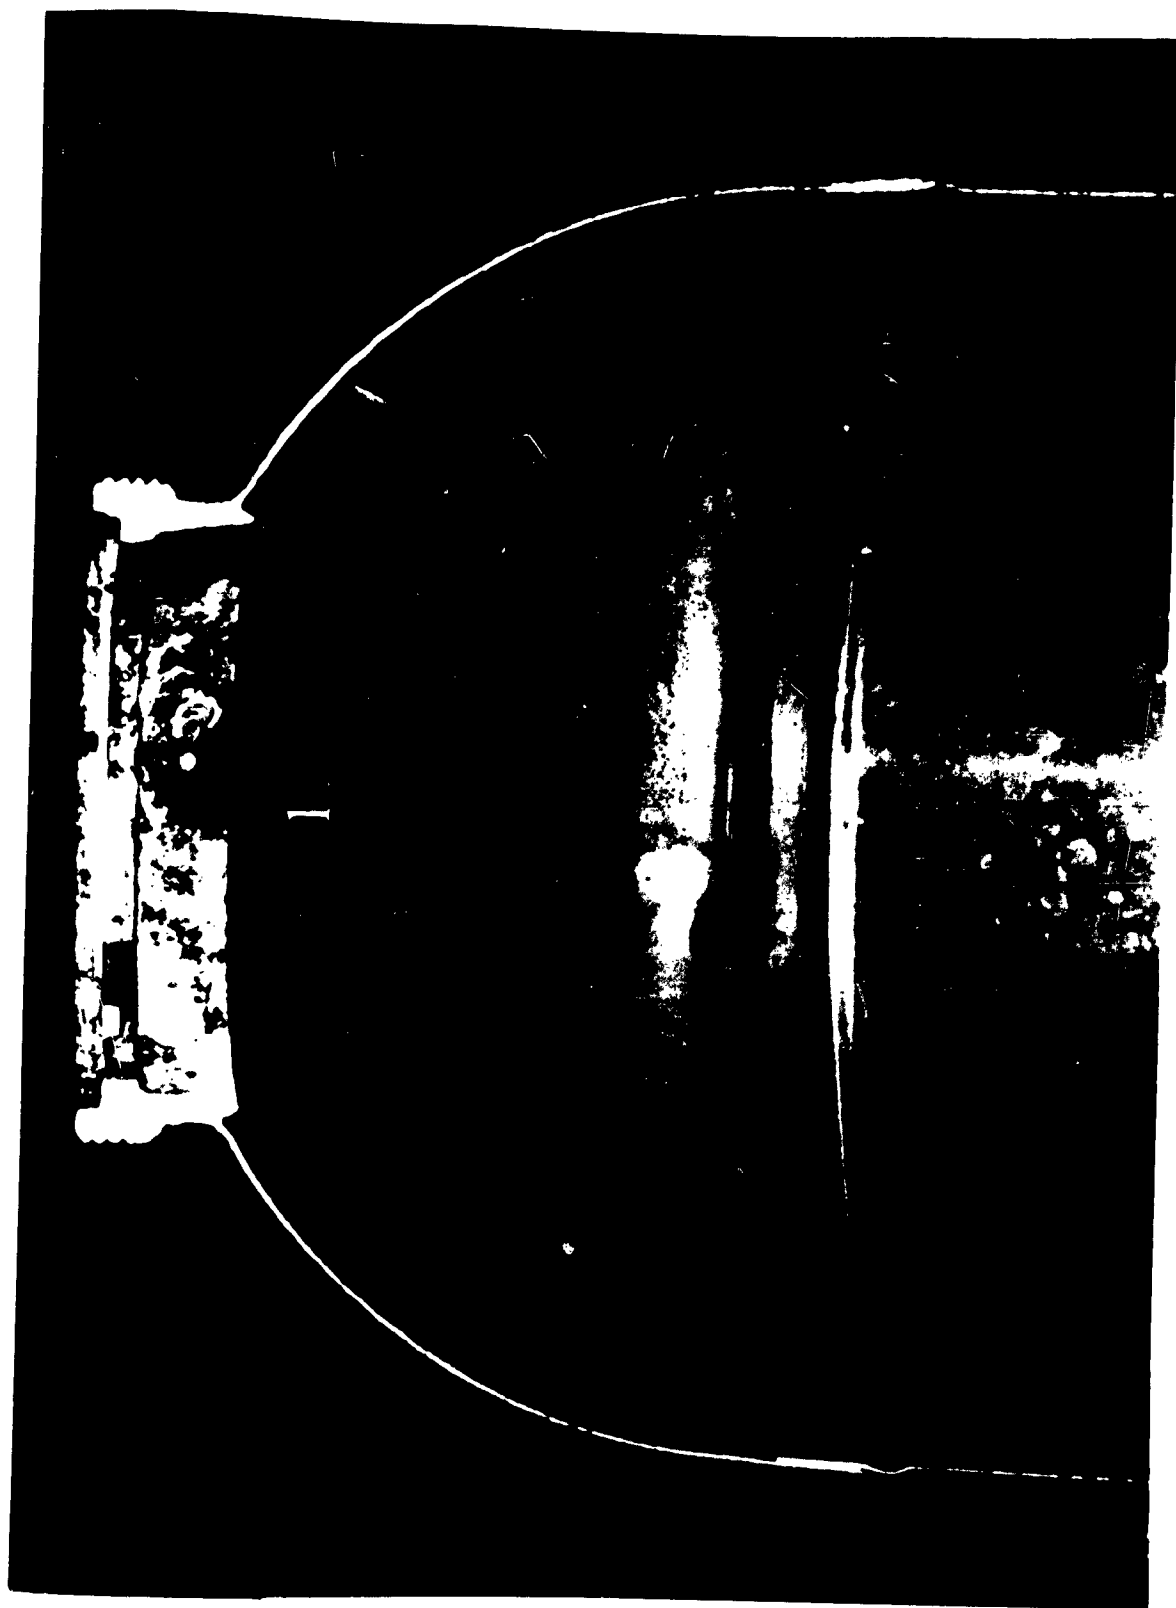
Figure 8. Stainless Steel Extinguisher No. 1, Top Inside. Greasy carbon film (right half) and clean metal after removal of film (left half).

The corrosion products found in the lithium chloride solution taken from the stainless steel extinguishers were mostly red rust. It will be noted that the top inside area of extinguisher 1 had very little corrosion (figure 8). This extinguisher, prior to its use in the accelerated corrosion test, had been used to test the NRL slow burning propellant. A thin film of a greasy carbon residue had formed over the upper surfaces of the extinguisher and offered considerable protection against the lithium chloride solution. This greasy film could be wiped off quite easily with a rag.
